## CASE STUDY

## HORSE STABLES

**CLIENT: A leading Australian horse breeder | LOCATION: Northern Victoria**

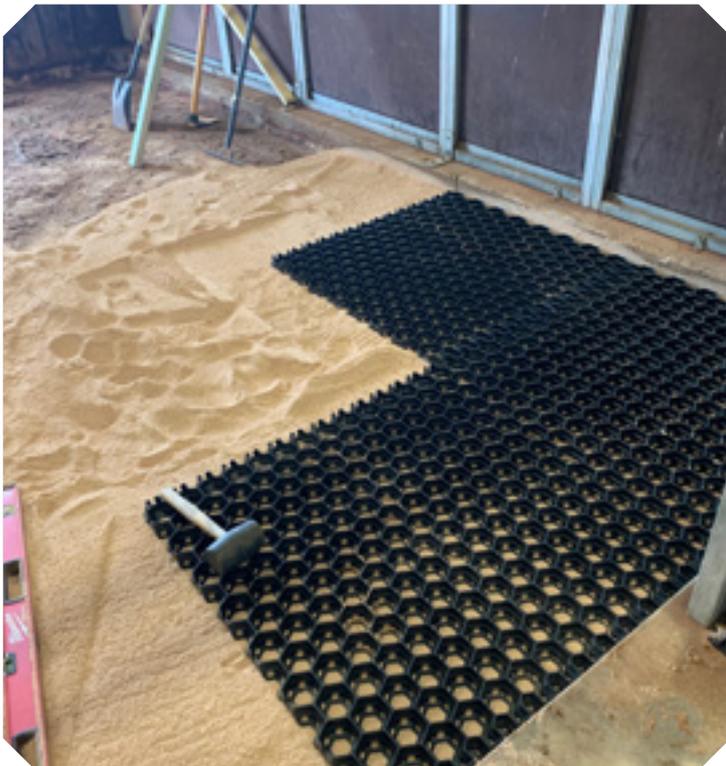
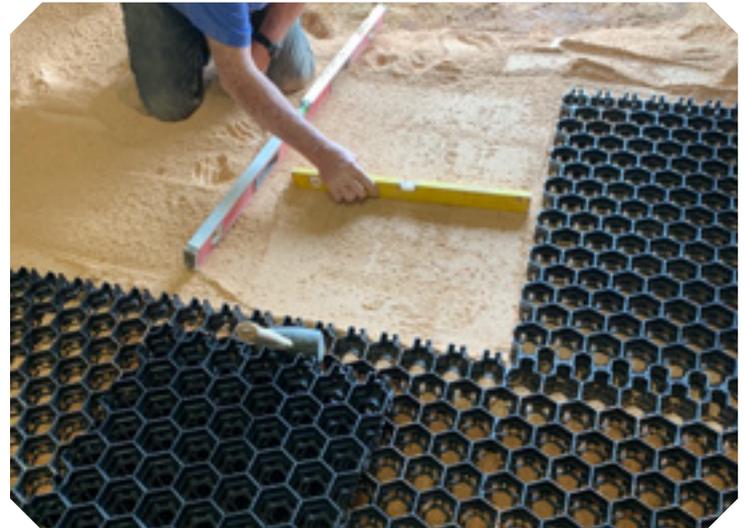
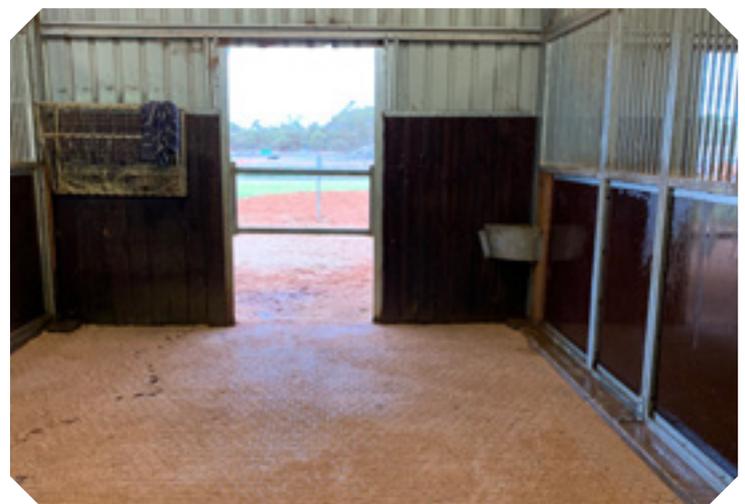
The client chose to install the GEOHEX Erosion Control System themselves – a common option for many GEOHEX clients, given that installing the product is a very simple process. The stable staff installed the GEOHEX using a rubber mallet to secure the GEOHEX panels into position in the base layer. A spirit level was then used to ensure the surface was level.

The client chose to use sand as the base layer underneath the GEOHEX system, with the infill material being a mixture of sand and sawdust. Once installed, the client spread a 100mm top layer of sawdust across the stable floors for added comfort and to deter the horses from eating the sand.

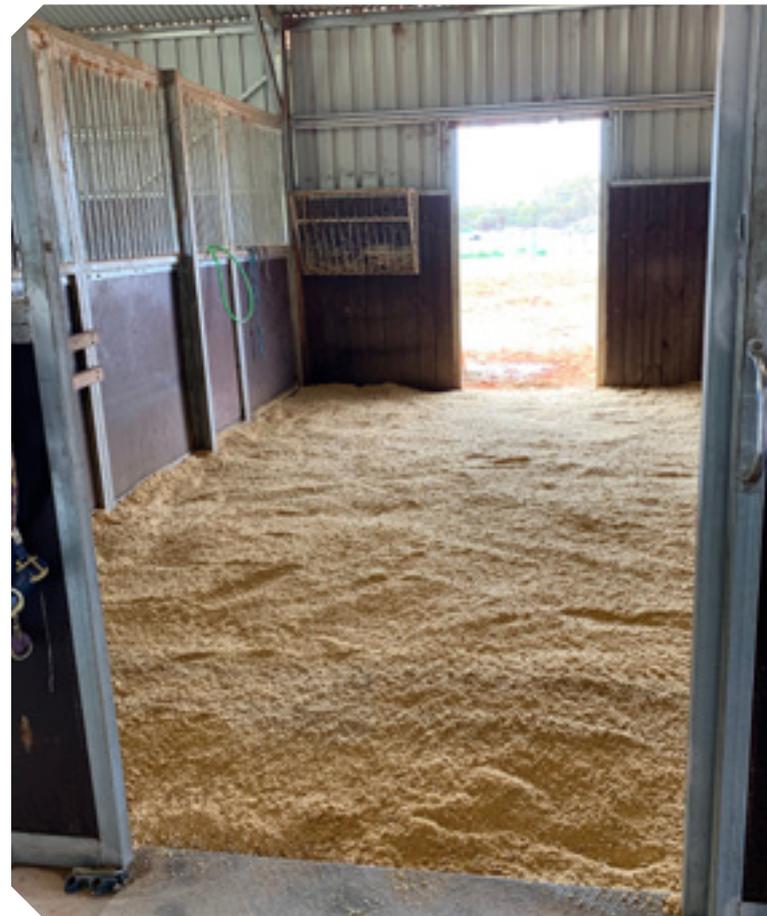
A total of 150m<sup>2</sup> of the GEOHEX Erosion Control System was installed across the four stables. As a result of delivering the comprehensive solution that was required, the client has since invested in more GEOHEX for the stud farm.
