CLIENT: RSPCA | LOCATION: Rural Australia

THE BRIEF:

THE SOLUTION:

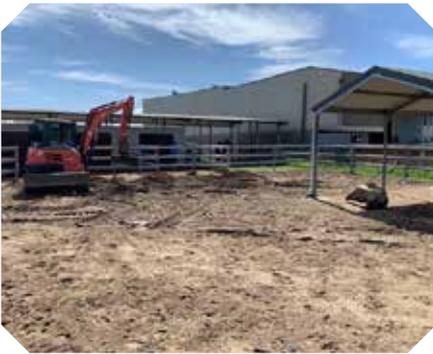
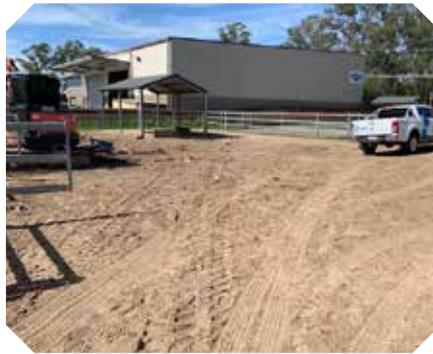
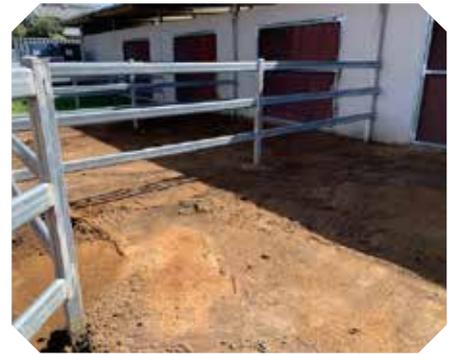
Before Geohex™ ▼

At its Queensland headquarters in the outer Brisbane suburb of Wacol exists a horse paddock that suffers from very poor drainage. Whenever it rained, the ground would become boggy and the majority of the sand base would wash away, exposing the drainage.

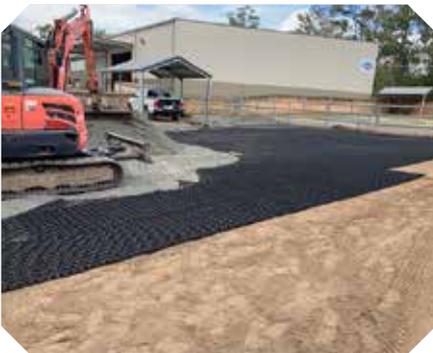
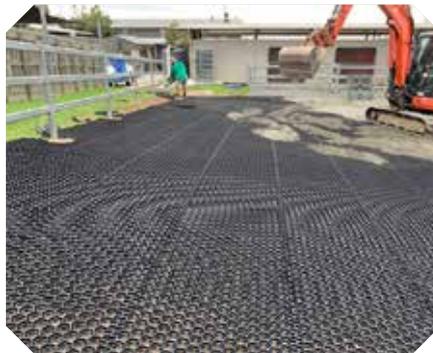
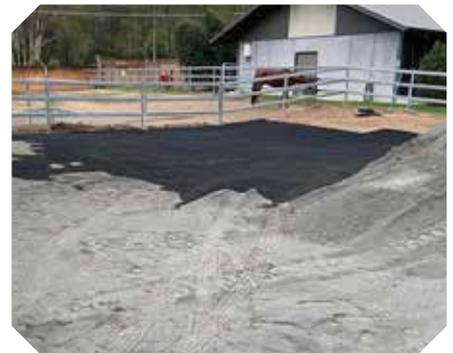
Installing Geohex™ ▼

GEOHEX and its contractor worked together to install the system in the horse yard as well as in four bays in front of the stables. A total of 680 square metres of GEOHEX was installed. The GEOHEX system was installed and then filled with crusher dust – a blue metal aggregate which provides a smooth, stable surface.

The GEOHEX Erosion Control System has been designed with a 99.7 per cent non-porous surface that has been engineered to allow rainwater to slowly run off into soil and then into the water table beneath, rather than having it run off into drainage. This minimises drainage issues and also supports the environment by contributing to water conservation.

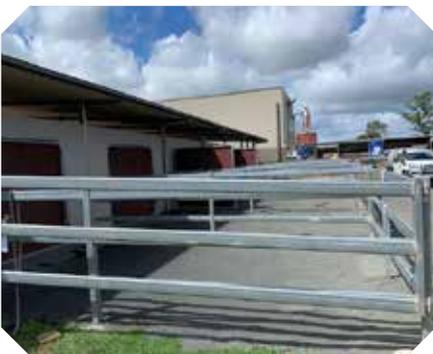
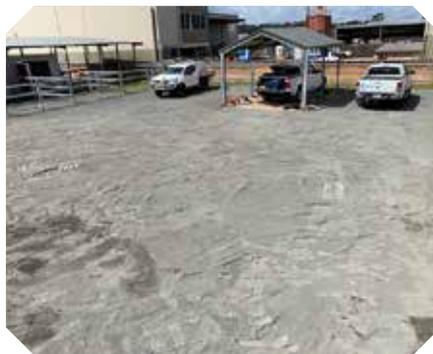
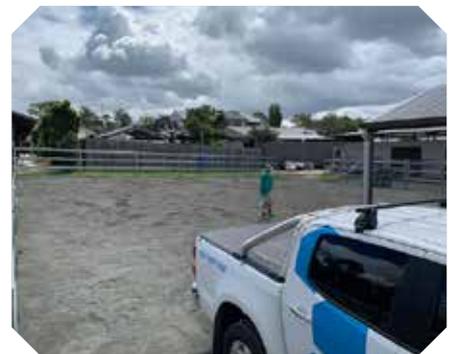
After Geohex™ ▼

"For us it's pointless taking neglected animals off other people and not looking after them in the best way possible," explains the RSPCA's David Jack. "This new surface makes that achievable. Since [GEOHEX] was installed we've had plenty of rain and there's been no flooding or bogginess. The animals are happy and we're really thrilled."
